T-SB-0058-24 July 8, 2024

# Manual Transmission Unable to Select Second, Fourth, and/or Sixth Gear

YEAR(S)	MODEL(S)	ADDITIONAL INFORMATION
2024	Tacoma

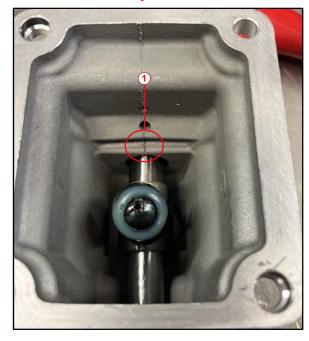
Figure 1. Floor Shift Control Shift Lever Retainer Sub-Assembly

Some 2024 model year Tacoma vehicles equipped with a RC60F manual transmission / transaxle may exhibit a condition where the vehicle is unable to shift into second, fourth, and/or sixth gear but is able to shift into all other gears. Further inspection shows signs of cracking from the floor shift control shift lever retainer sub-assembly housing. To address this condition, the manual transmission assembly needs to be replaced. Follow the Repair Procedure in this bulletin to address this condition.

Inspect the floor shift control shift lever retainer sub-assembly for the cracking condition.

Does the retainer show signs of cracking as shown in Figure 1?

1 Example of Retainer Cracking

- Replace the manual transmission assembly.
  Refer to TIS, applicable model and model year Repair Manual:
  - <u>2024</u> Tacoma:
    Drivetrain RC60F (Manual Transmission / Transaxle) –
    Manual Transmission Assembly Installation
- 6. Test drive the vehicle and confirm the condition no longer exists.
